TEST OF AN ELECTROHYDRAULIC DIGITAL ACTUATOR FOR ADVANCED MISSILE SYSTEMS

TECHNICAL REPORT AFWAL-TR-80-2001

Final Report for Period September 1978 - September 1979

BENDIX RESEARCH LABORATORY
REPORT OF REACTION PIN SPACER
FAILURE

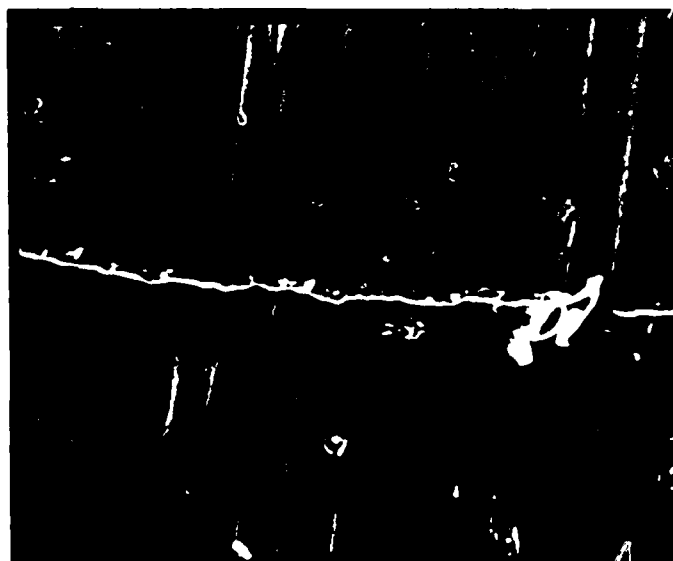
The outer surface of the spacer which failed during the life test contains a large number of deep long cracks, originating on the surface and running parallel to the spacer axis. Evidence of abrasive wear and some adhesive wear damage and poor surface finish (from machining) is observed, along with residue of debris particles and chips (Figures 2 to 6).

Figure 2. Outer surface of pin spacer piece A (of Fig. 1), showing the presence of deep long cracks running parrallel to the spacer length. Evidence of abrasive wear and poor initial surface finsih (machining) is observed, along with the presence of debris and chips.

1. The contacting surfaces (rotor and spacer) must be fabricated to a smooth surface finish, and thoroughly cleaned following the lengthy machining and heat treatment step, so as to minimize the presence of trapped particles and avoid surface damage by wear.
2. Again, final machining should be carried out gently and in no way should result in surface scoring, and damage, since fatigue life of the spacer is very sensitive to its surface condition.
3. During the heat treatment, triple tempering in air might be replaced by a double treatment in an inert atmosphere, and hardness values 60 Rc or higher should be achieved (this also provides the desired alloy high compressive strength).

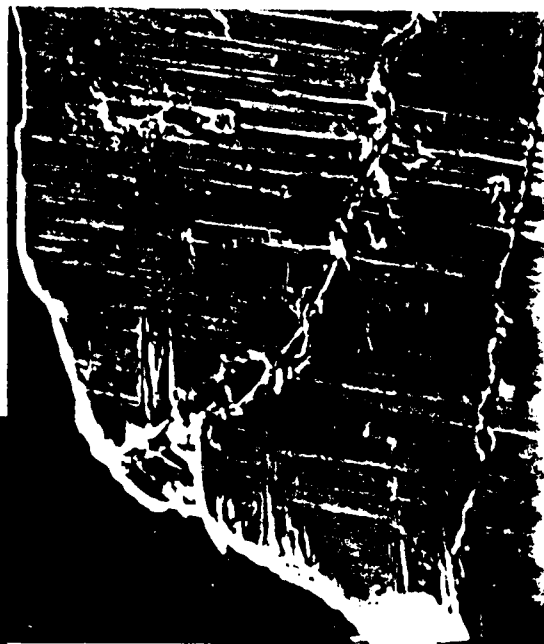
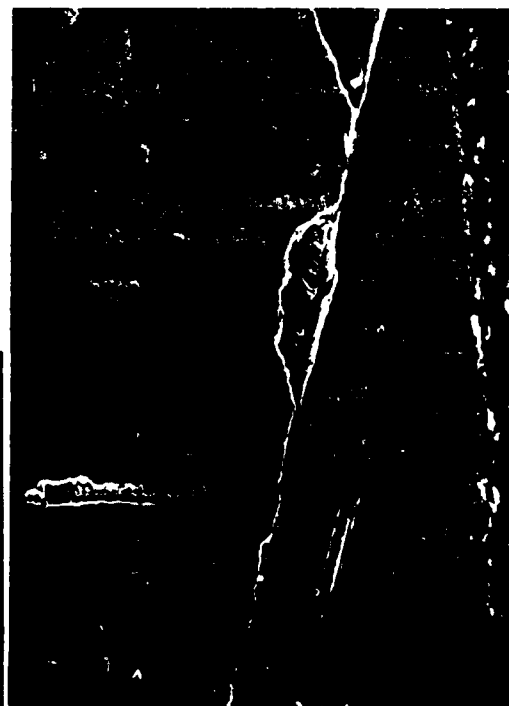
Figure 3. Outer surface of Pin spacer piece B, showing abraded surface full of scratches, surface pits, and many cracks originating from the spacer outer surface.

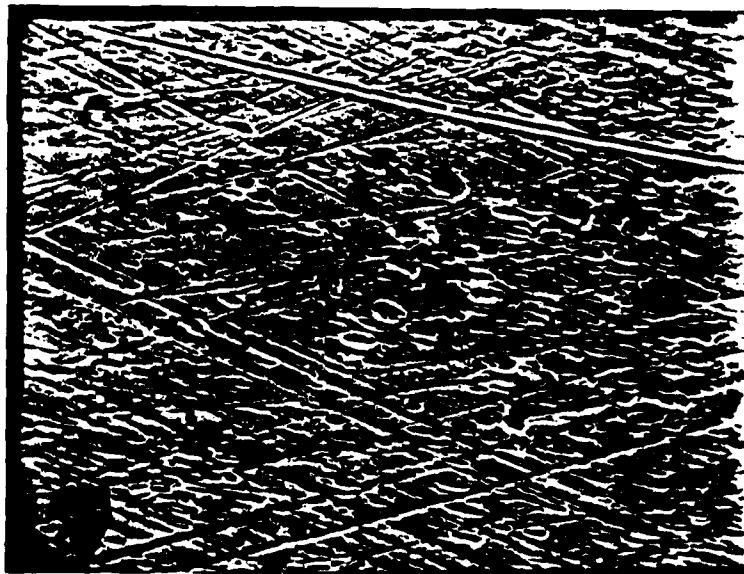
Both inner and outer surfaces of those spacers which passed the life test show little damage and cracking, some brinelling (surface indentations), and contain almost no trapped particle (or debris)(Figure 8 and 9).

Figure-8. An example of the inner surface of those pin-spacers which passed the life test with no failure. Brinelling or surface indentations are observed, probably caused by debris formed from the contacting surfaces during testing. The extent of damage observed here is far less than that of the failed spacer inner surface.

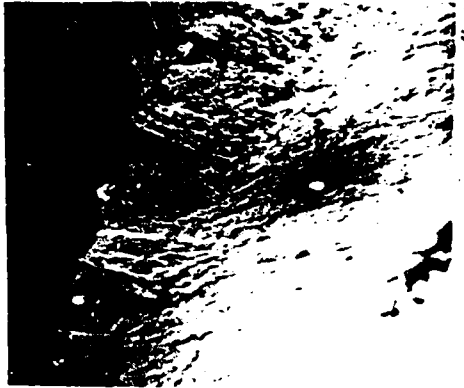
Some crack sites on the inner wall of the spacer as a result of poor machining
